Manhole Inspection Summary

Manhole # S37AA1005MH

Insp Date: **1/3/07 9:10 AM**

Location Address: **3501 OLD YORK RD**

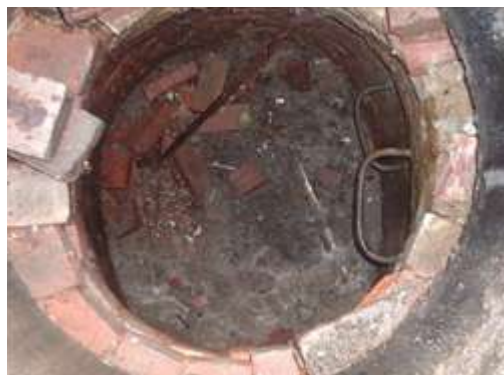
Top View

Channel debris.

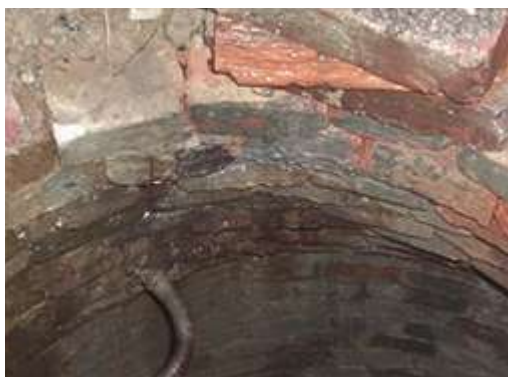
Defect

Frame leaks. Frame offset. Adjustment deterioration, loose brick and infiltration. Corbel infiltration.

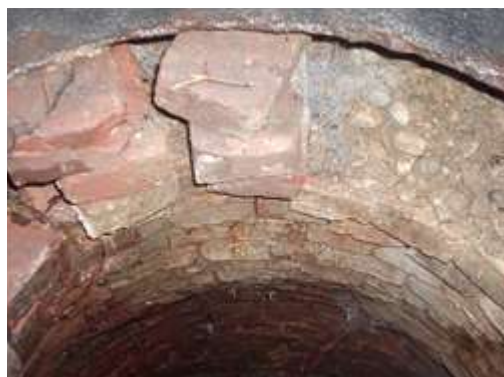
Defect

Frame leaks. Frame offset. Adjustment deterioration, loose brick and infiltration.

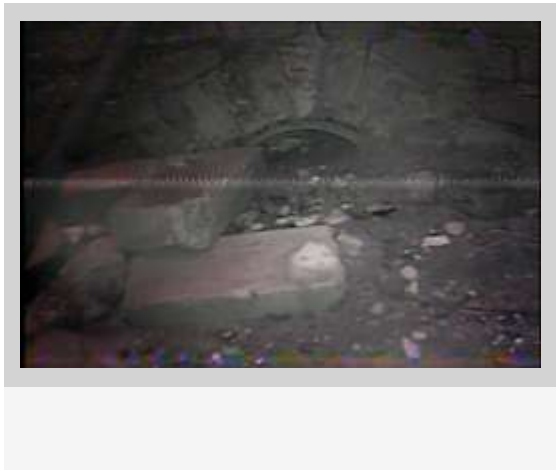
8 in. Circular Gravity Sewer
Pipe Out @ 12 O'Clock

Deposits: ☐ None ☒ **Mud** ☐ Sludge ☒ **Debris** ☐ Grease

Silt Depth: **5** (in.) Deposits Extent: **Heavy**
